Retesting of Lead and Nickel Levels in Rainwater Tanks at Esperance

February, 2008

**THE UNIVERSITY OF
WESTERN AUSTRALIA**

**Dr Jane Heyworth
School of Population Health
Crawley, Western Australia 6009**

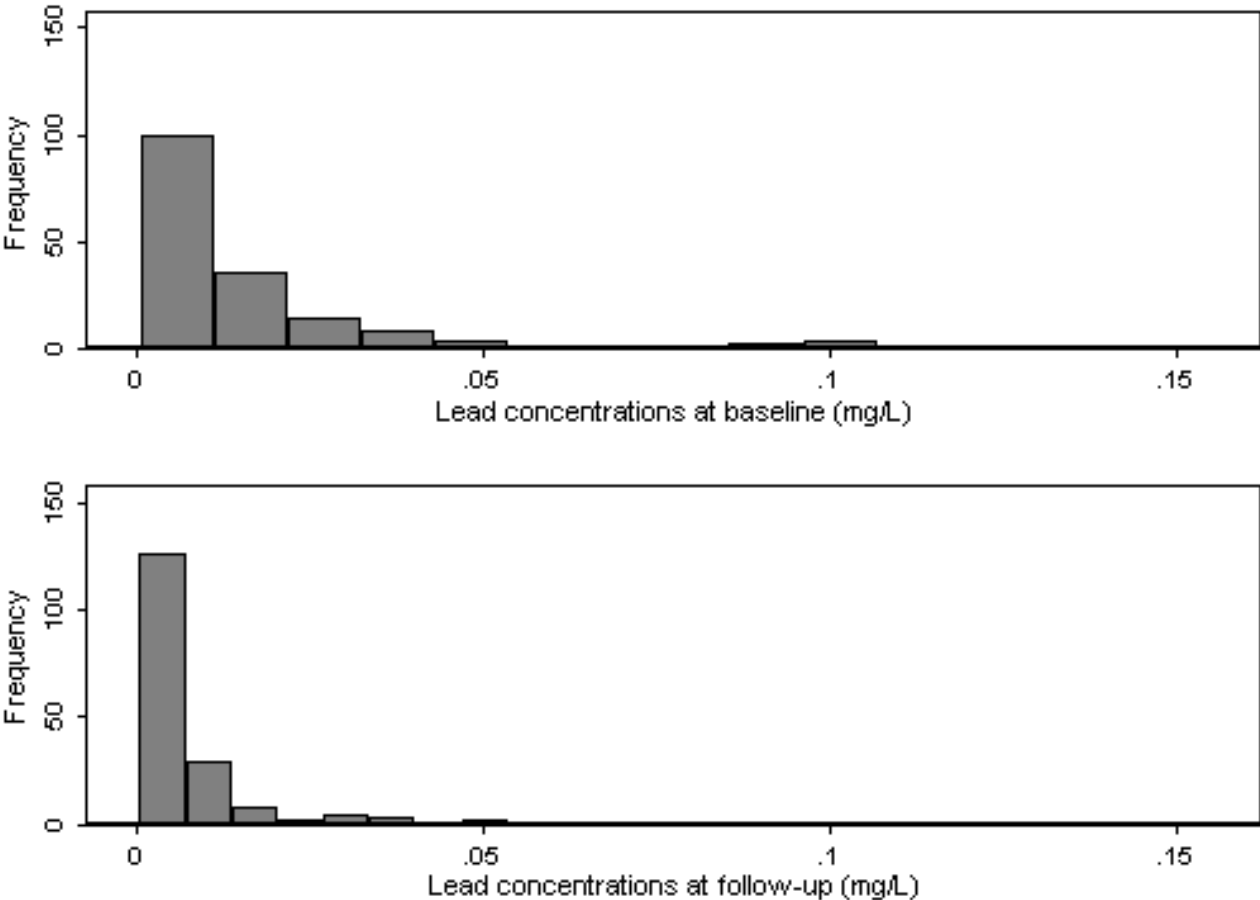
Figure 7 Distribution of lead concentrations at baseline and follow-up

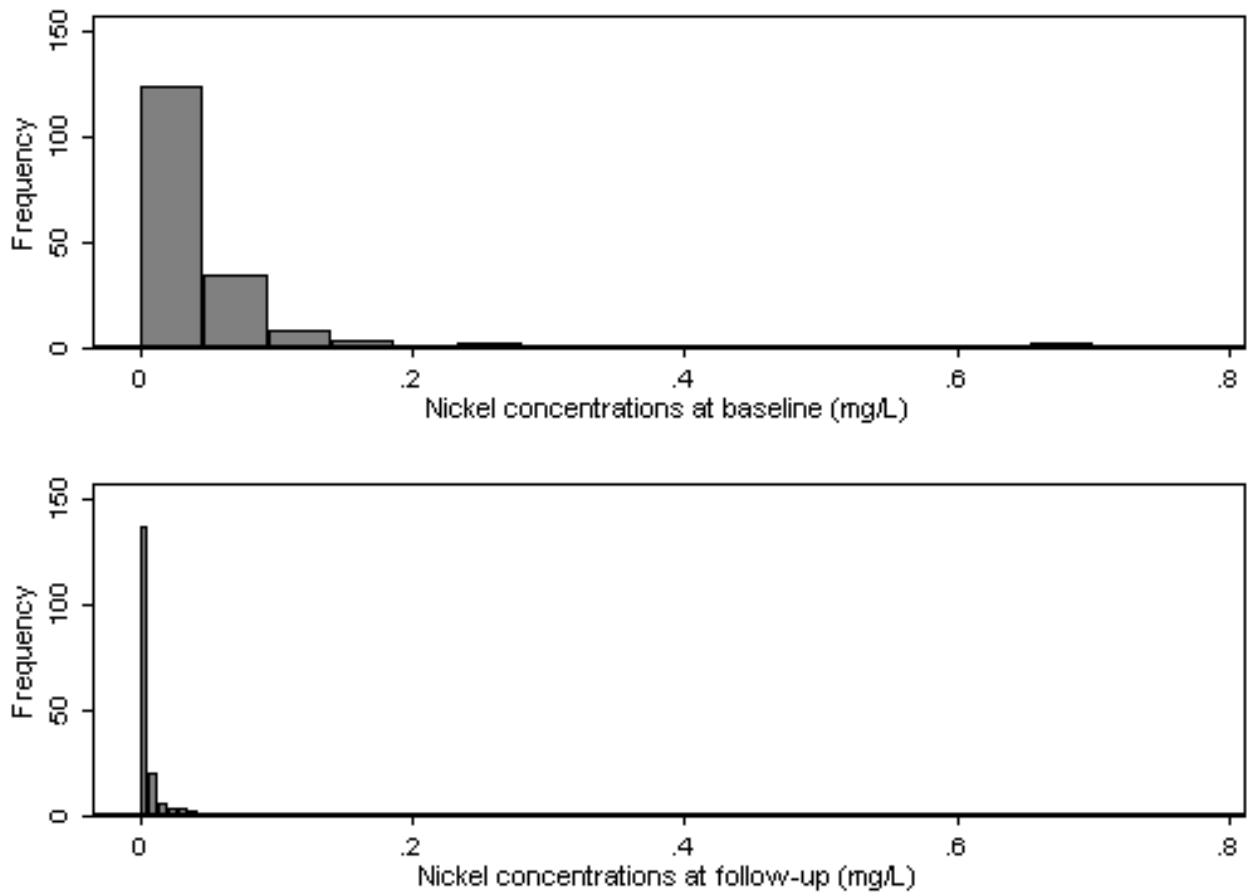
Figure 8 Distribution of nickel concentrations at baseline
